# Manhole Inspection Summary

Manhole # S41UU\_014MH

Insp Date: **2/15/07 2:53 PM**

**Location** Address: **1405 GORSUCH AVE**

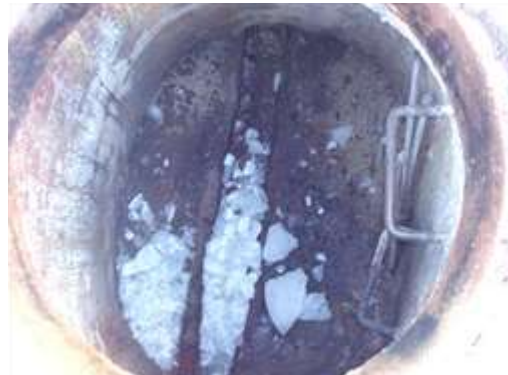
Top View

Bench and Channel debris.

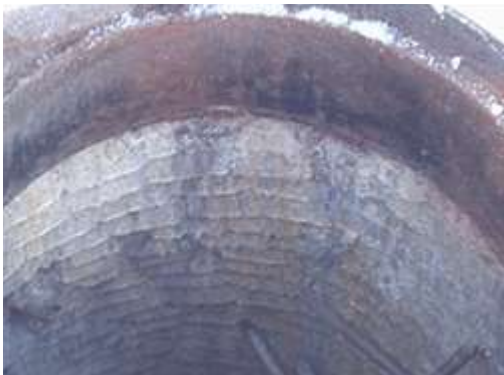
Defect

**Frame** Offset: **0** (in.) Condition: ☐ Sound ☐ Cracked ☒ **Leaks**

Condition: ☐ Sound ☐ Cracked ☐ Root Intrusion ☒ **Loose Brick** ☒ **Deteriorated**

Infiltration: ☐ None ☒ **Joint** ☐ Cracks ☐ Mortar ☐ Roots ☒ **Wall**

Infiltration: ☐ None ☐ Joint ☐ Cracks ☒ **Mortar** ☐ Roots ☒ **Wall**

Frame leaks. Corbel deterioration, loose brick and infiltration. Barrel infiltration.

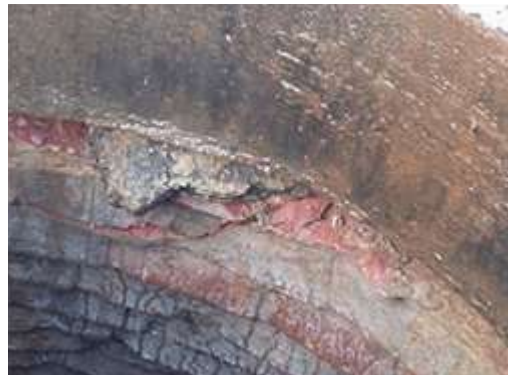
Defect

Frame leaks. Corbel deterioration, loose brick and infiltration.

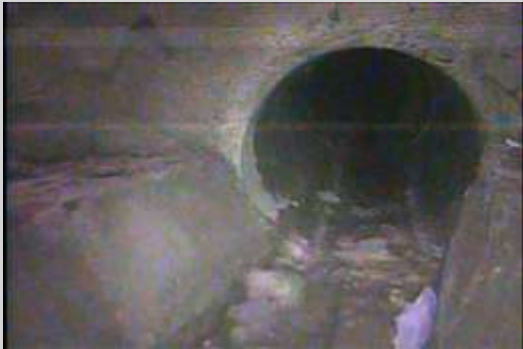
### 8 in. Circular Gravity Sewer Pipe Out @ 12 O'Clock

Deposits: ☐ None ☒ **Mud** ☐ Sludge ☒ **Debris** ☐ Grease

Silt Depth: **0.5** (in.) Deposits Extent: **Light**
